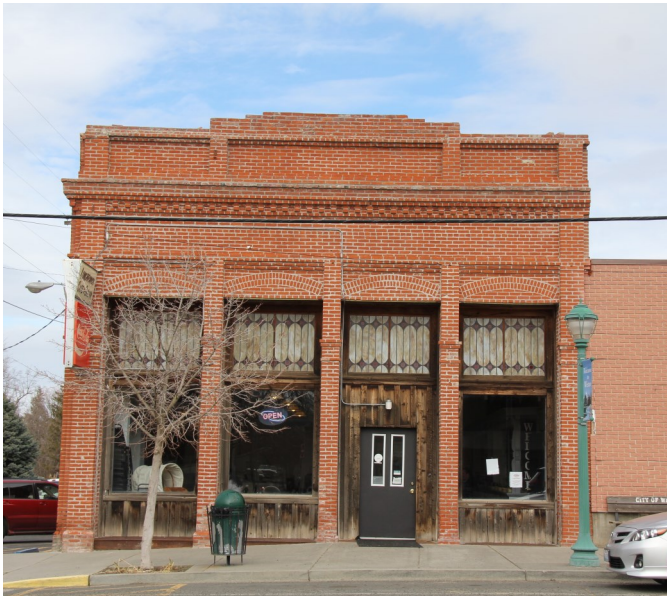
**Left photo:** Front of building.  
**Right top:** West Wall of building before fire. Note steel shutter near front of building.  
**Right:** West Wall after fire. Windows that need to be filled in and loose and missing bricks.

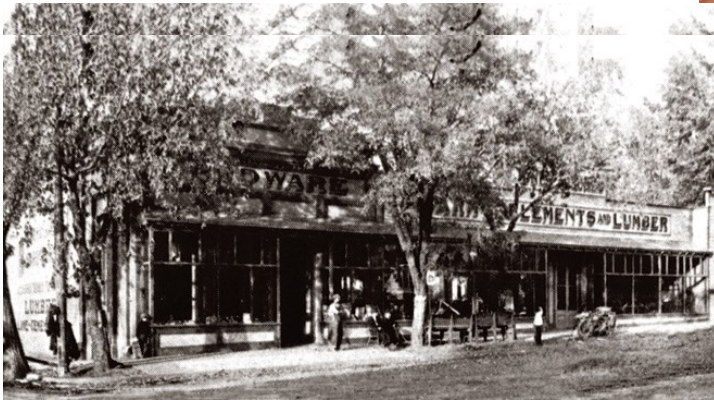
**Left:** Entire building after 1920. Note the large windows and double entry doors.

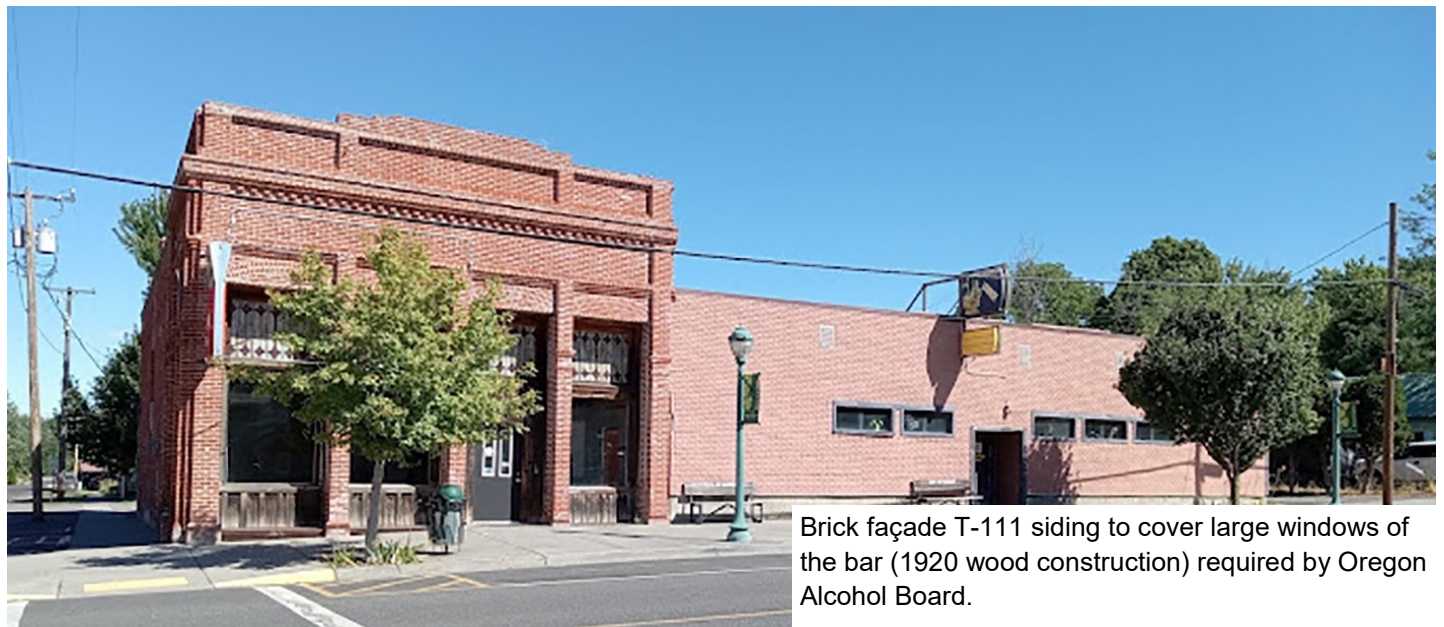
Brick façade T-11 siding to cover large windows of the bar (1920 wood construction) required by Oregon Alcohol Board.
